National Register of Historic Places Registration Form

historic name Dayton State Bank

street & number 133 C Street

city or town Dayton

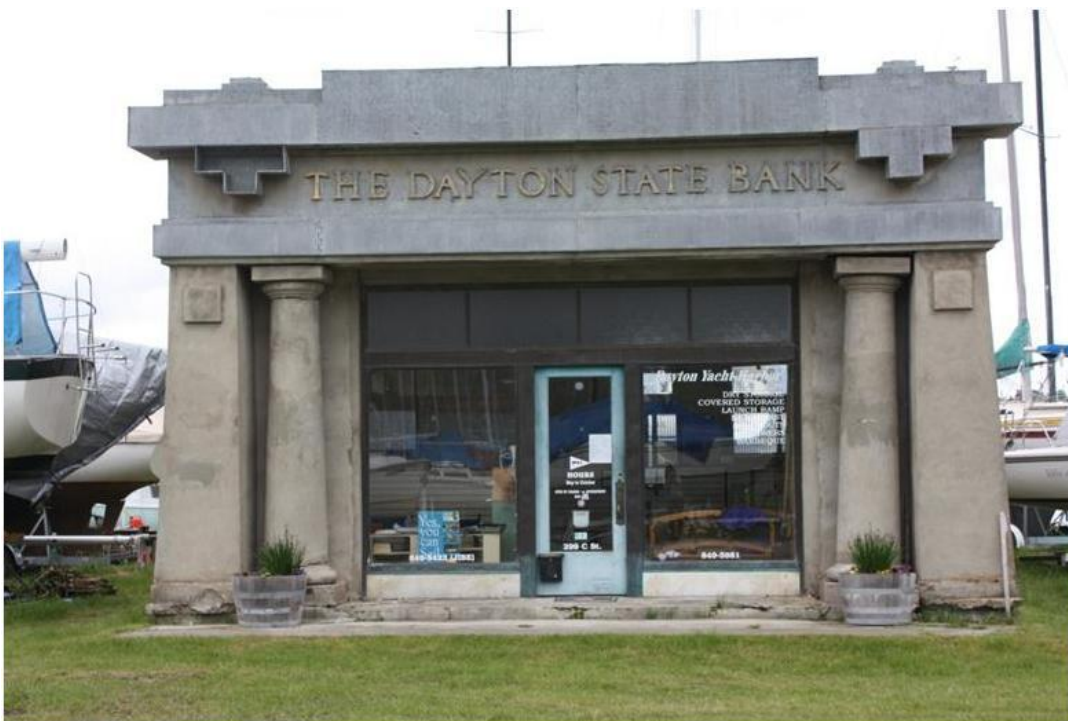
Photo 0001: Primary Elevation, West façade, View to the east.

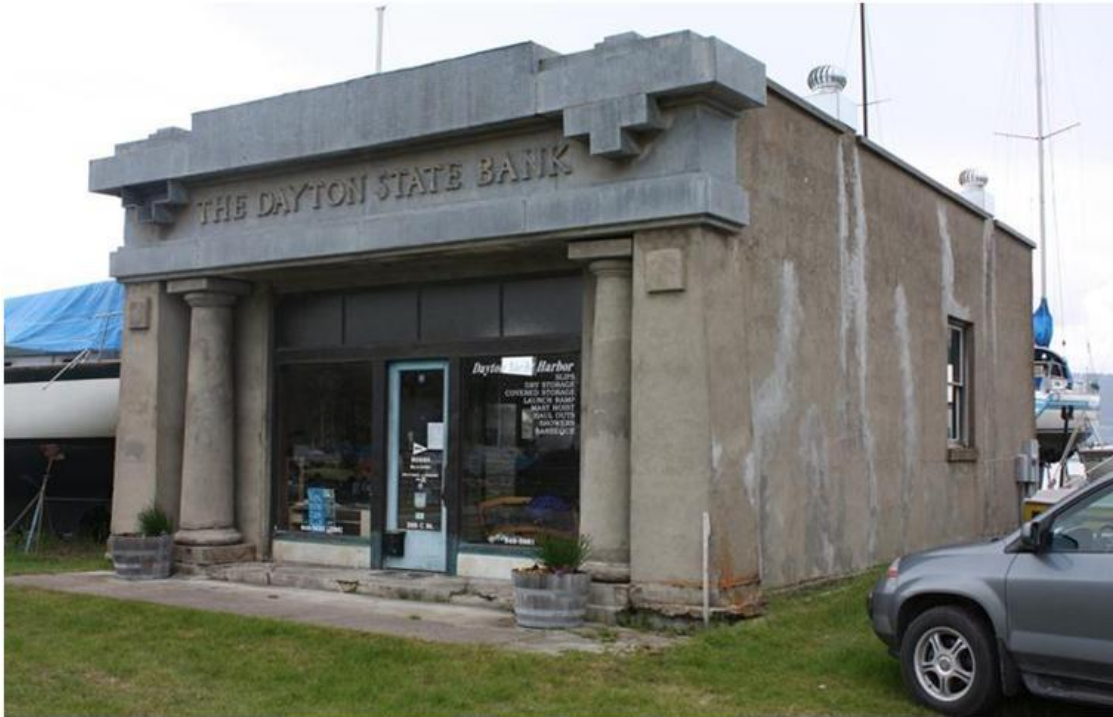
Photo 0002: Above: West and south facades, view to the northeast

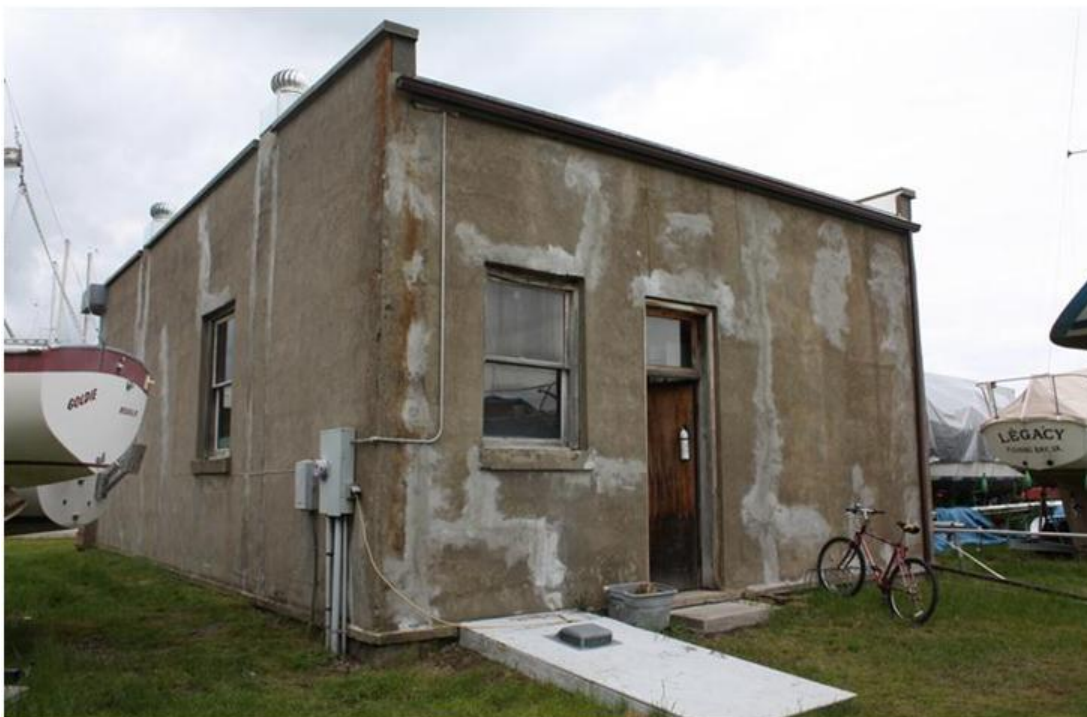
Photo 0003: Below: West and north facades, view to the southeast.

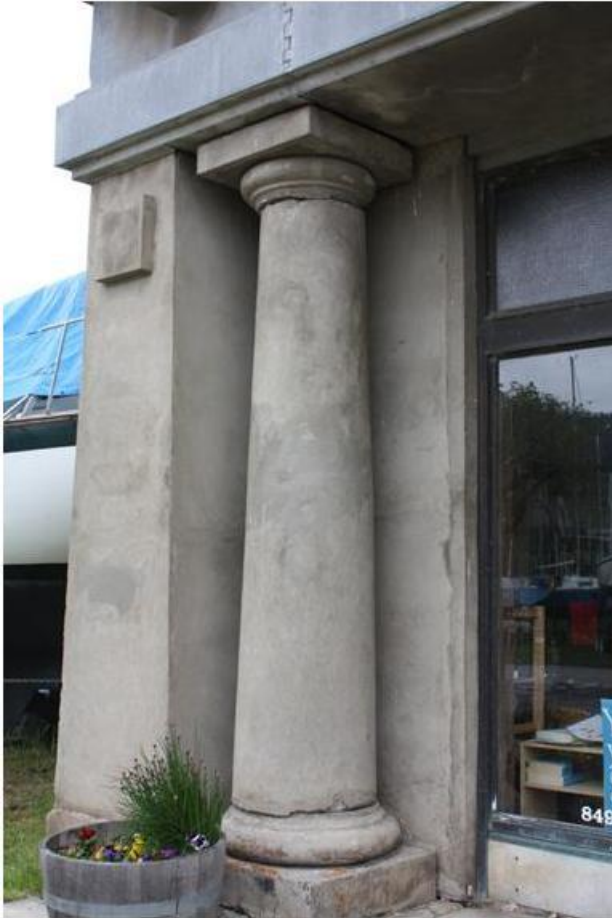
Photo 0004: Left: Corner detail

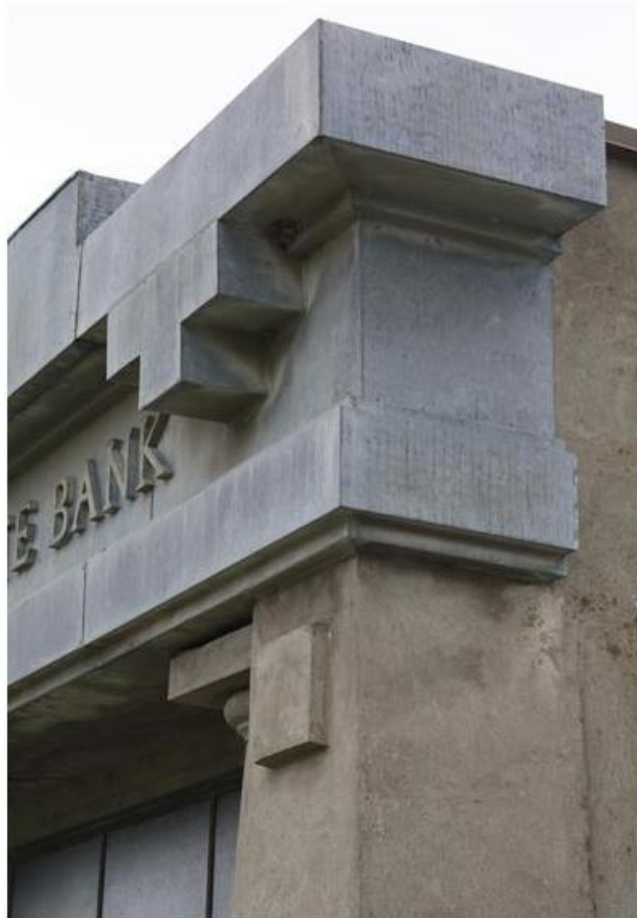
Photo 0005: Right: Engaged Pillar and Column

Engaged square columns trim the south wall, and historically, a large clock hung in the space between them. There is also a poured concrete fireplace that echoes the design of the façade, with a heavy square-pedimented mantle, engaged square columns at the corners and a concrete hearth in this wall. Originally, there was a cherry floor; it is no longer extant and has been replaced with plywood. Beneath the building, is a basement with a dirt floor that houses the heating system and storage.

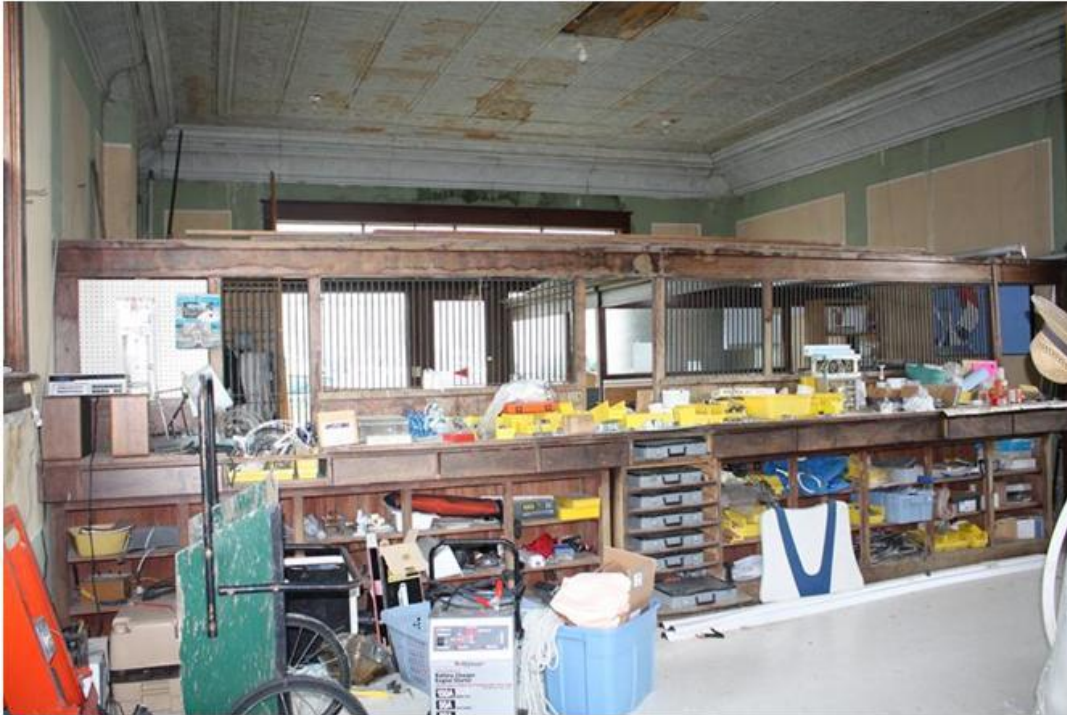
Photo 6: Above: Bank Interior from behind teller wall, view to the west toward front.

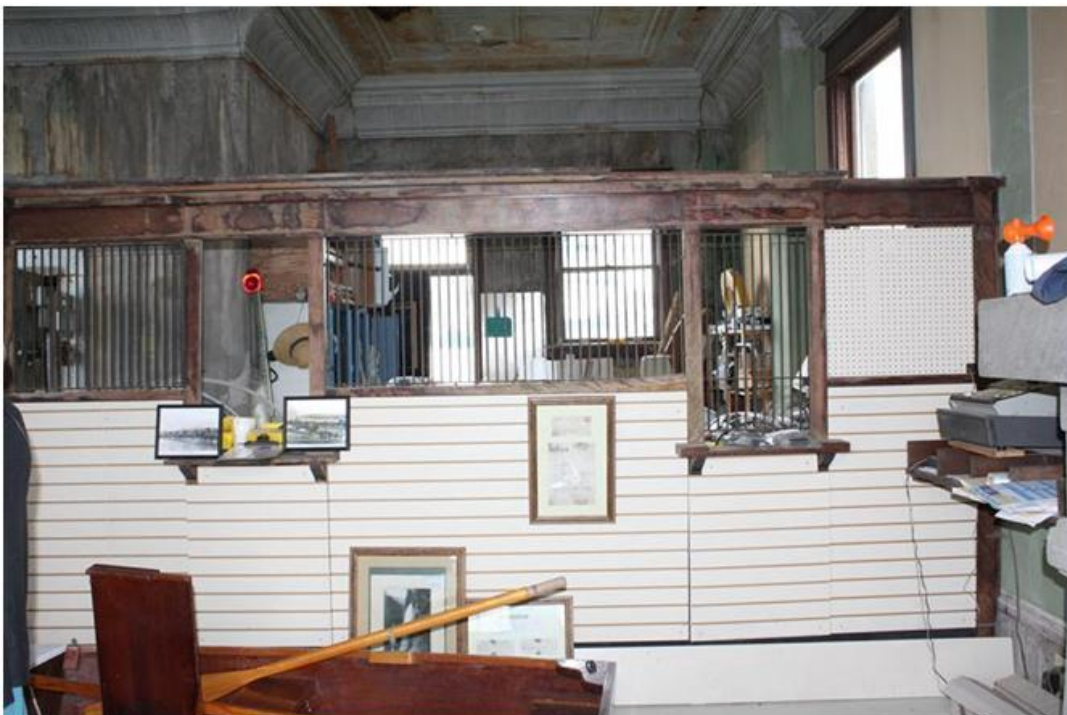
Photo 7: Below: Bank Interior, Teller Wall looking east from front entrance.

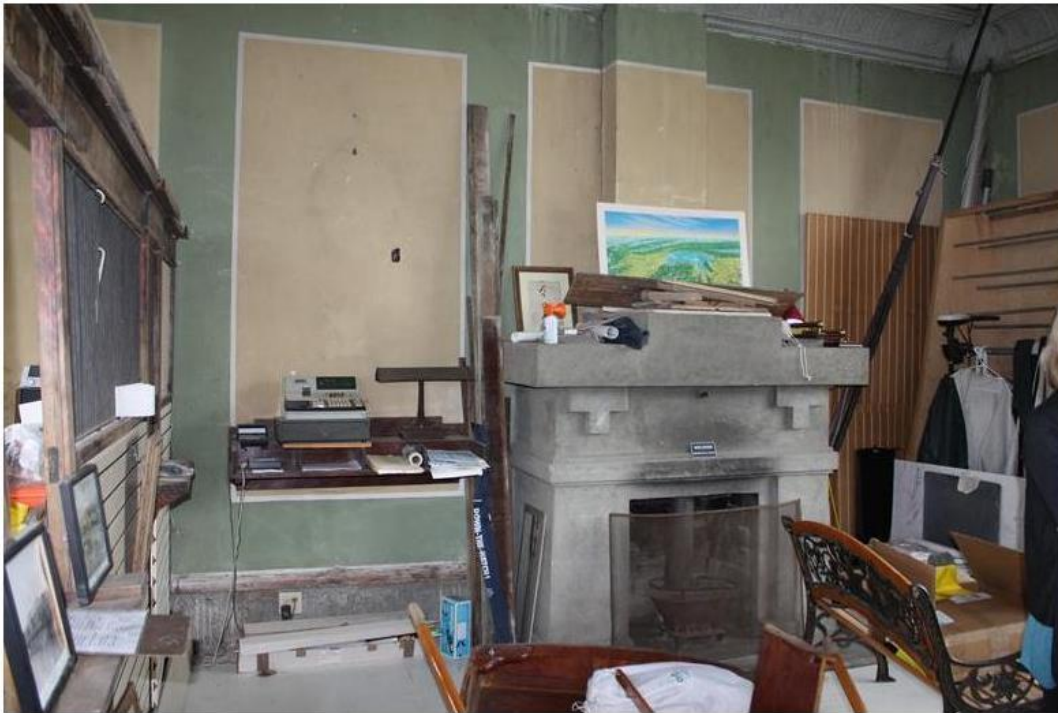
Photo000 8: Bank Interior, North wall with fireplace.

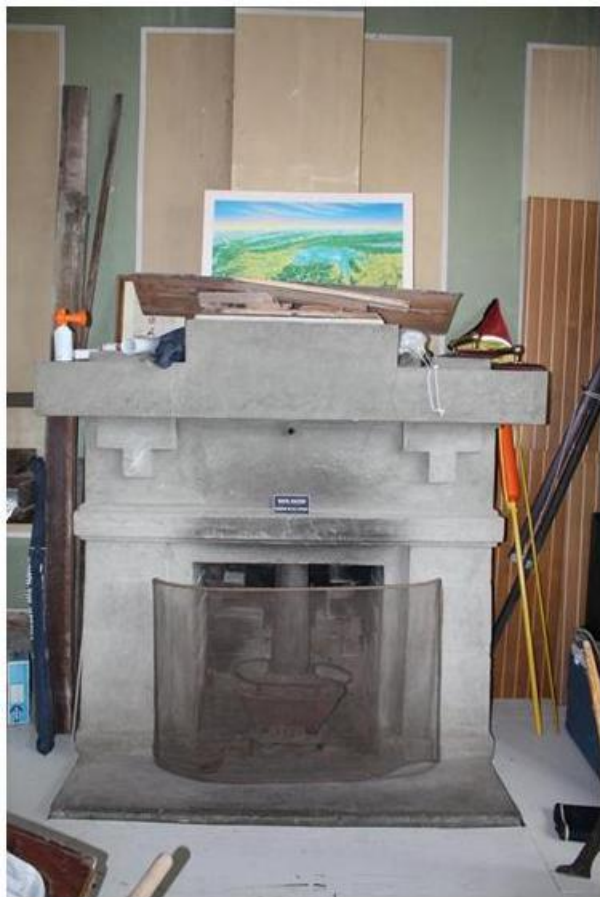
Photo000 9: Fireplace Detail

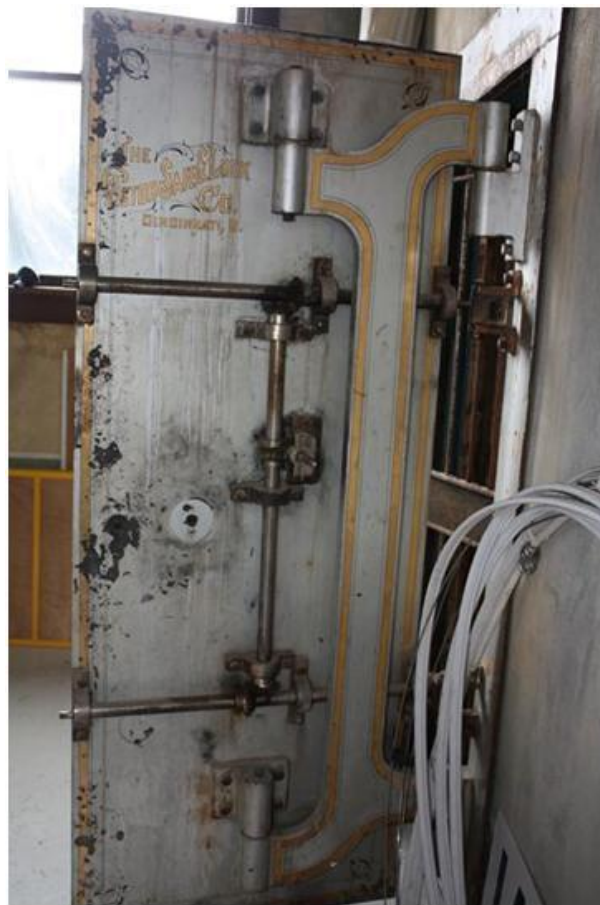
Photo0010: Vault Door, Manufactured by Victor Safe & Lock Co, Cincinnati, OH.

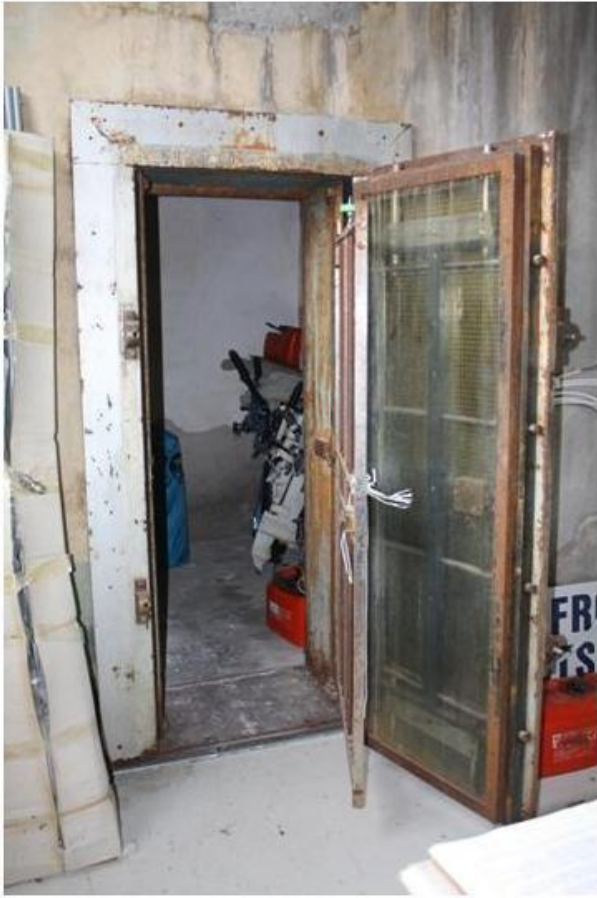
Photo 0011: Vault Interior

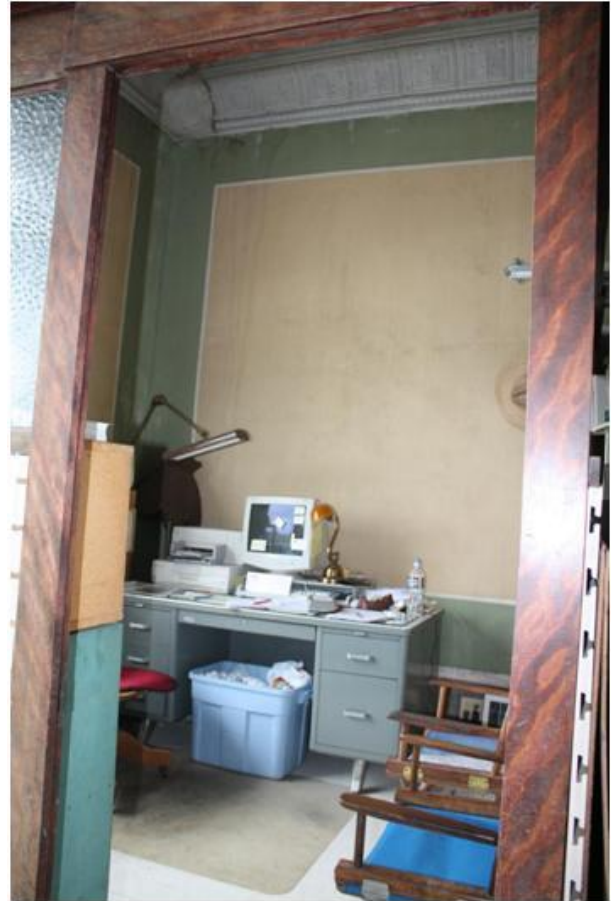
Photo 0012: Front office, northeast corner of bank interior.

On the interior, the building is a large open space, with a small office partitioned in the front northwest corner. The office is enclosed by a $\frac{3}{4}$ wall with dark mahogany-stained wood trim and textured privacy glass. The bank interior is divided by a teller cage wall that extends across the center of the building from north to south. The teller cage wall is wooden with iron grillwork and is finished in a rich dark mahogany stain, to match the interior trim. The bank's concrete walls are covered with a finish concrete skim-coat that was painted green with large gold panels outlined in white. These original finishes remain, as well as the original ornamental tin ceiling.

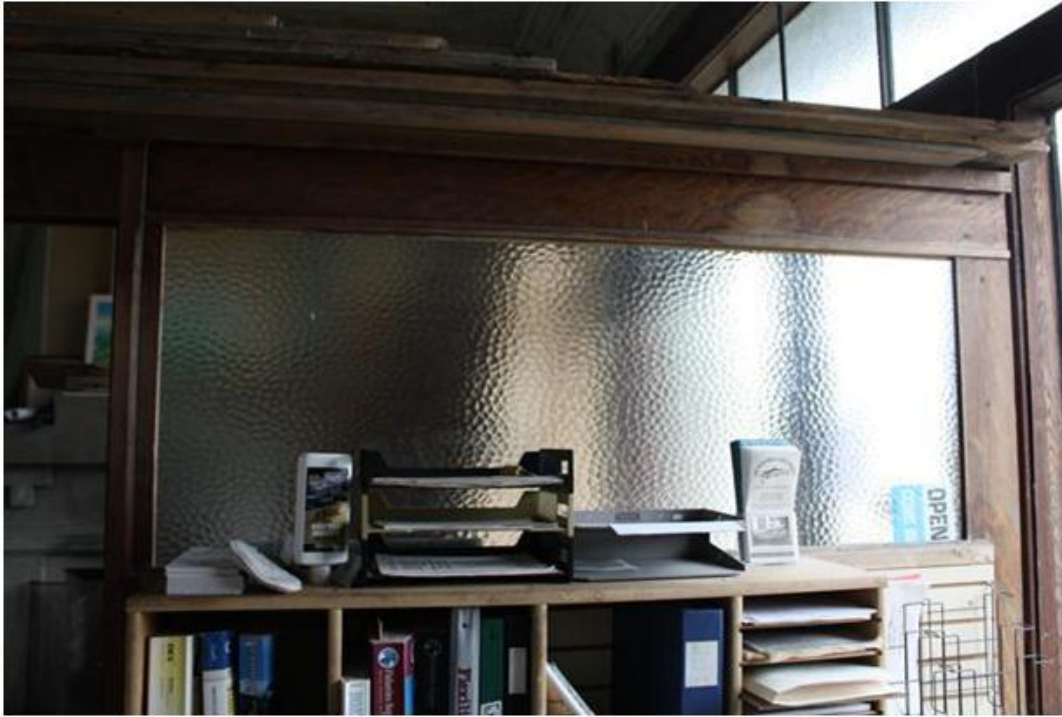
Photo 0013: Front office, northeast corner of bank interior.

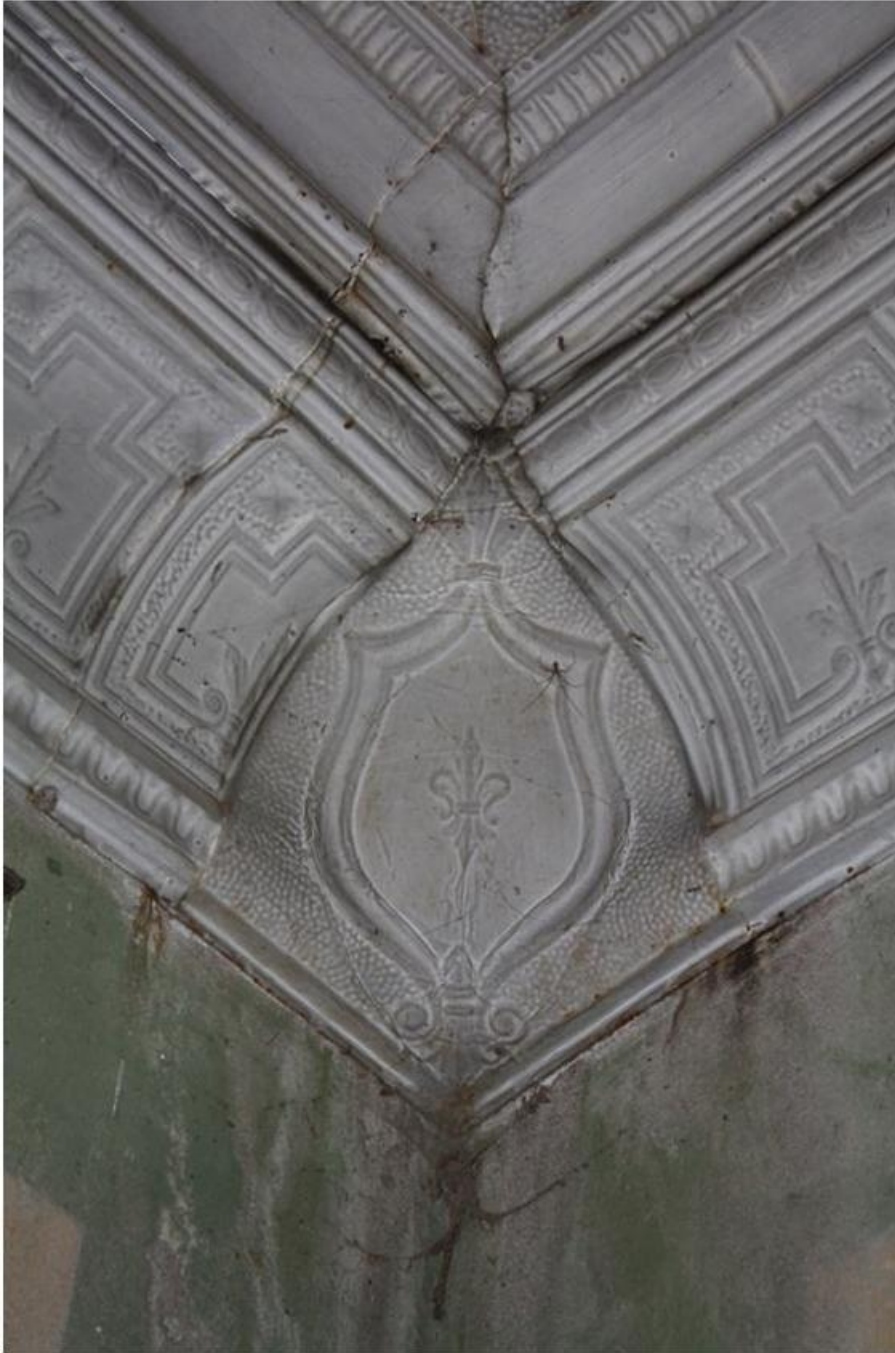
Photo 14: Detail view of ornamental pressed-tin ceiling.

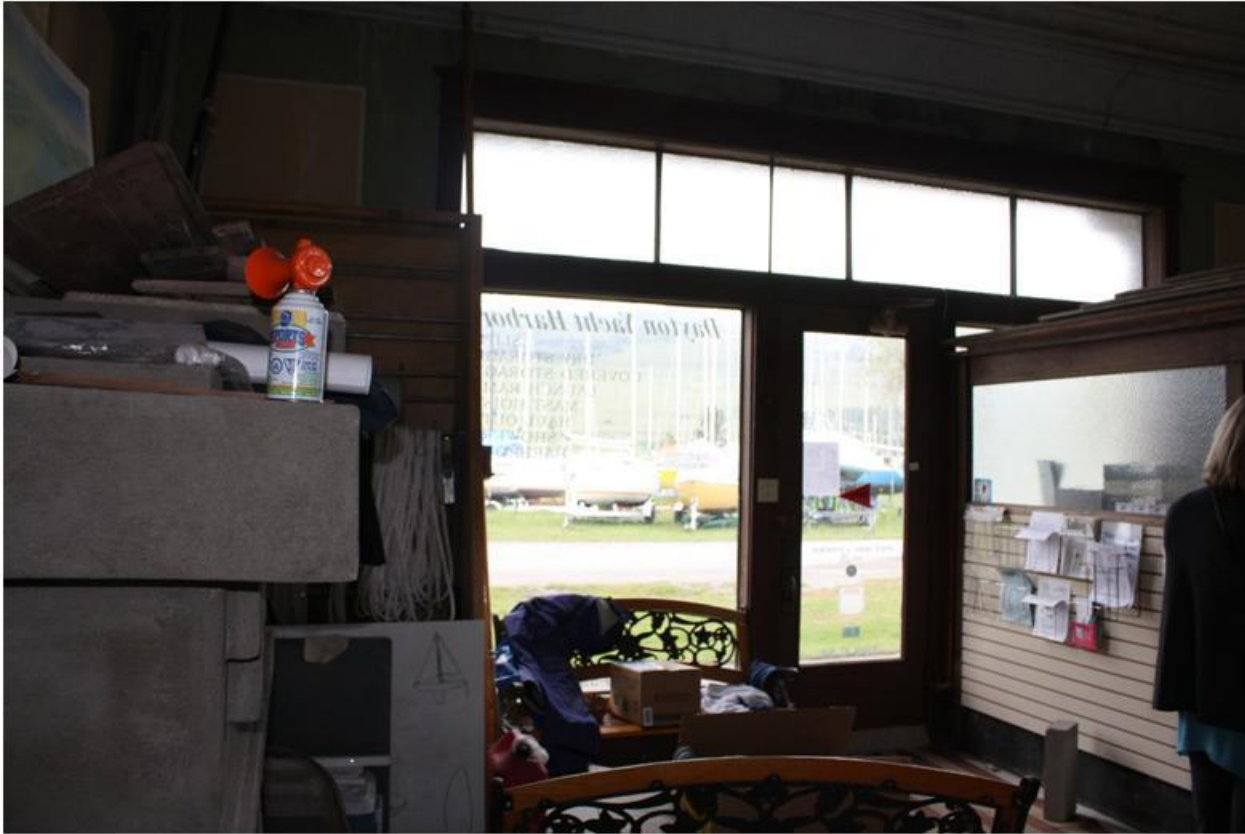
Photo 15: Bank Interior, Front Area looking west toward front windows and doorway.
